HISTORIC STRUCTURE REPORT:
THE CUSTOM HOUSE AND TOWER

VOLUME II:
EXISTING CONDITIONS AND RECOMMENDATIONS

SARA B. CHASE
and
ANNE A. GRADY

SOCIETY FOR THE PRESERVATION OF
NEW ENGLAND ANTIQUITIES
CONSERVATION CENTER

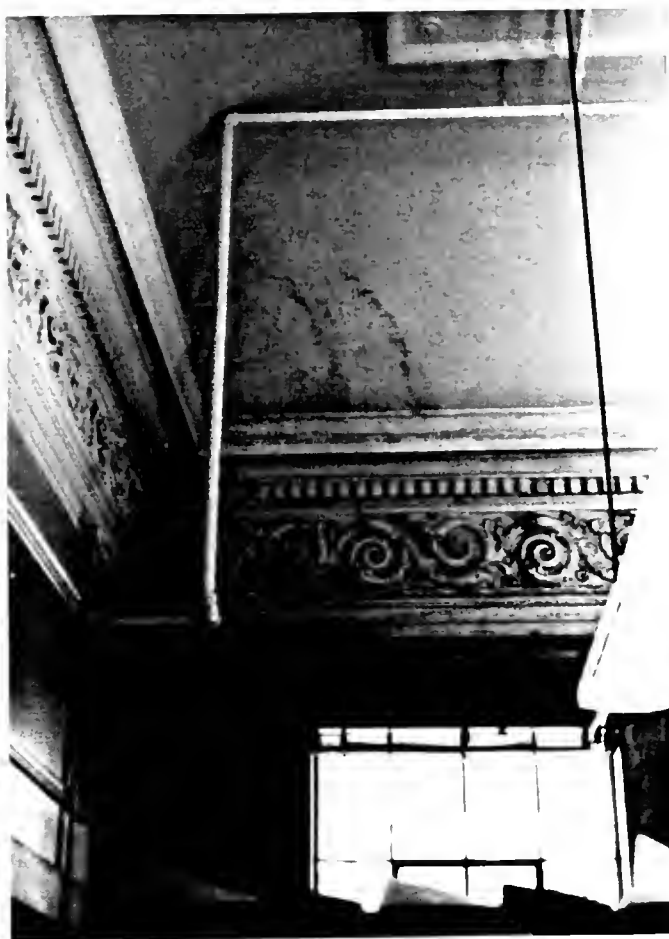
2-11; Auditor's room, south wing, northeast corner.

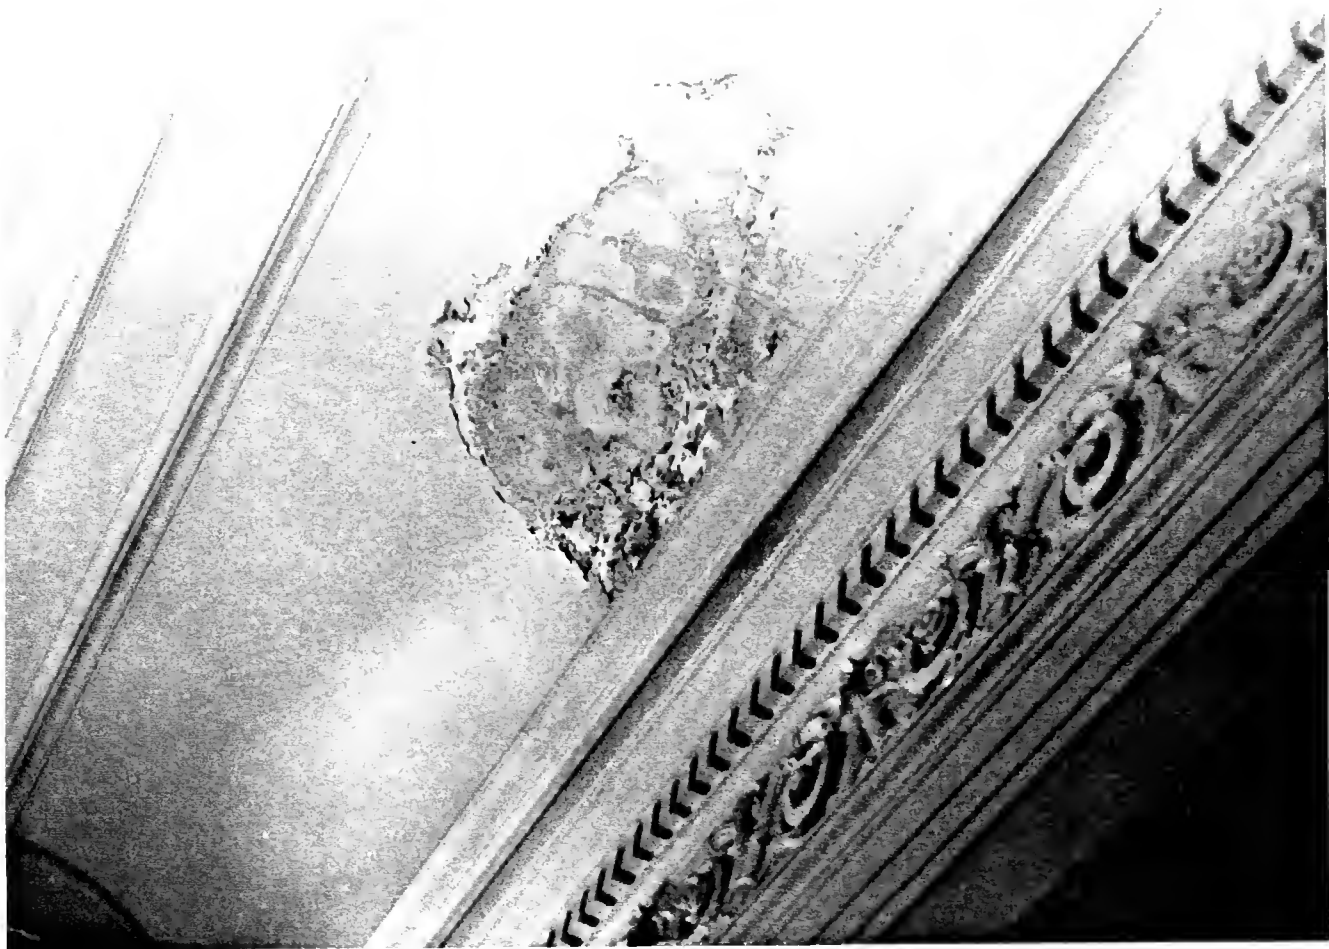
2-12; Detail, coved ceiling, Auditor's room, south wing.

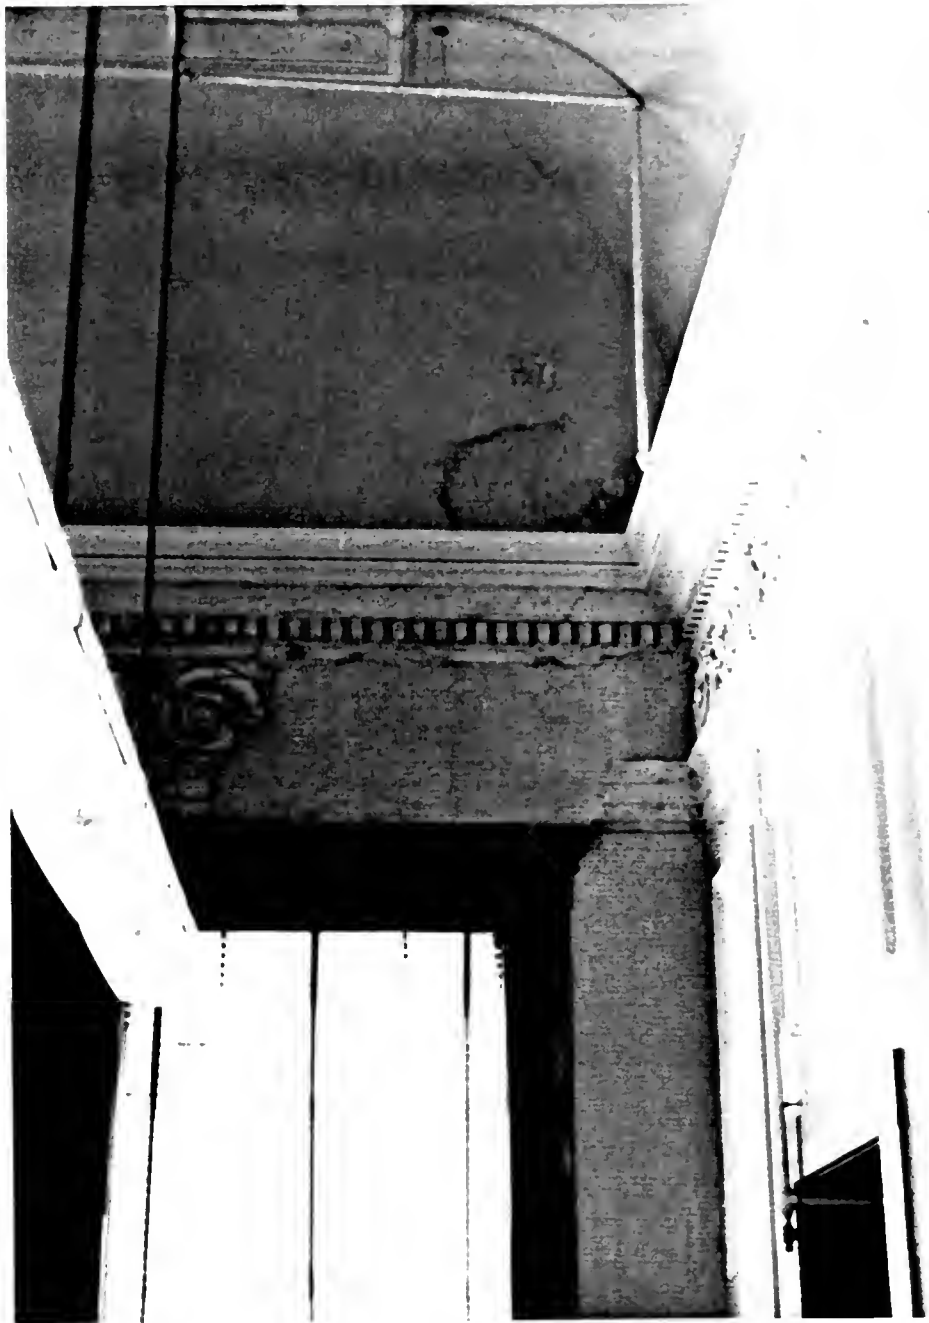
2-13; Auditor's room, south wing, northwest corner.

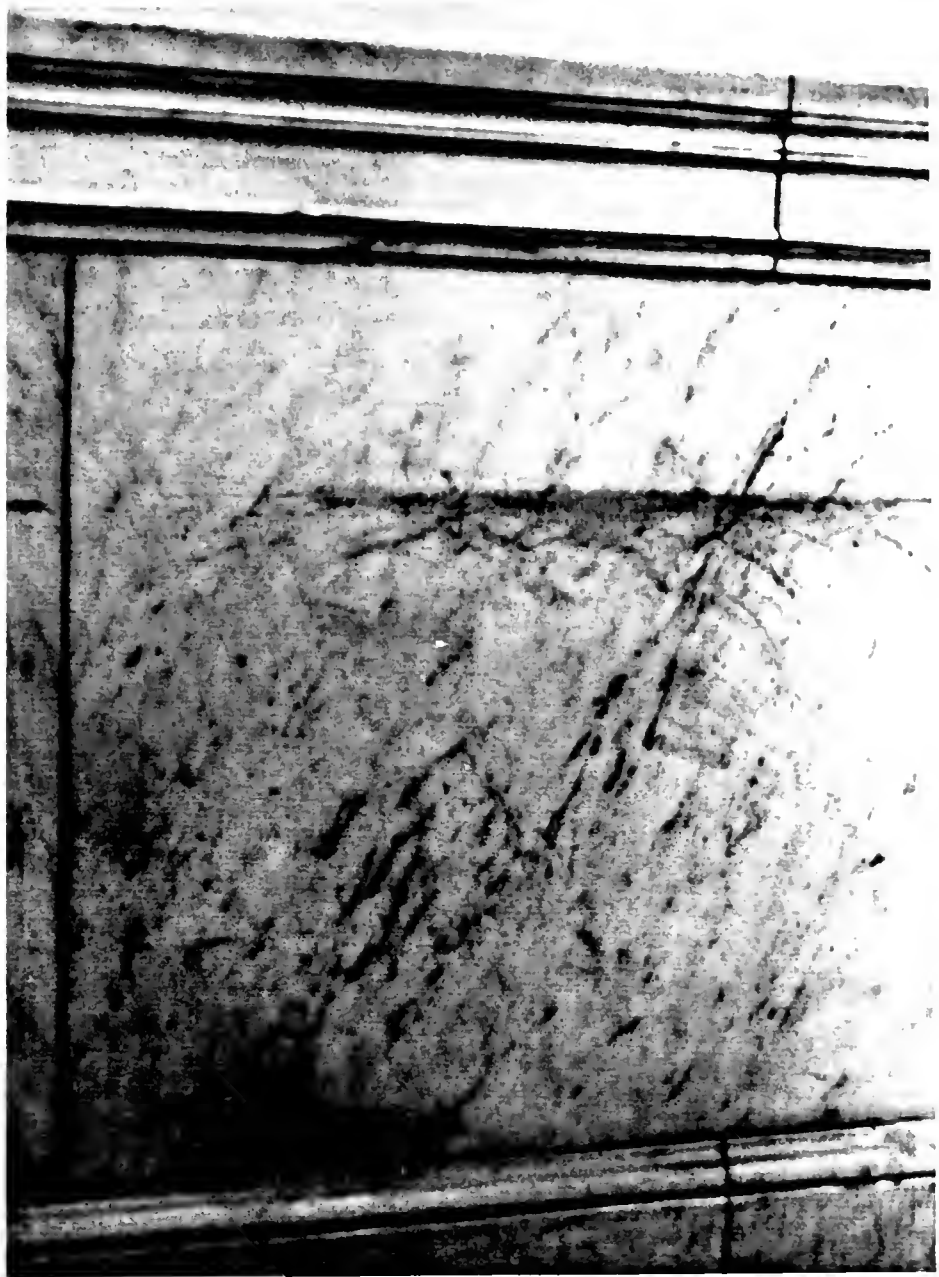
Element	Material/Description	Condition	Photo#
Floor	carpet over ?	poor	
Base-board	marble, molded	scratched & dirty - fair	2-14, 15
Walls	paneled plaster over low marble wainscot	some dirt, scratches, chips, abrasion	2-14, 15, 16
Cornice	molded plaster and rinceau	NE & NW corners - missing - much water damage	2-9
Ceiling	coved plaster	good except small spot in center & NE & NW corners, and N side	2-9, 10, 11, 12, 13
Windows	steel sash	corroded	
Window Frames	marble	soiled, dull, nicked	2-9, 11, 13
Doors	grained metal	painted over on rotunda side; needs cleaning and touch-up	
Door Frames	grained metal architraves	need cleaning and touch-up	
Hardware	brass	dull	
Elect. Fixt.	egg crate		2-9
Special Features			
Remarks

2-15; Auditor's room, wainscot on north wall,
to west of main door.

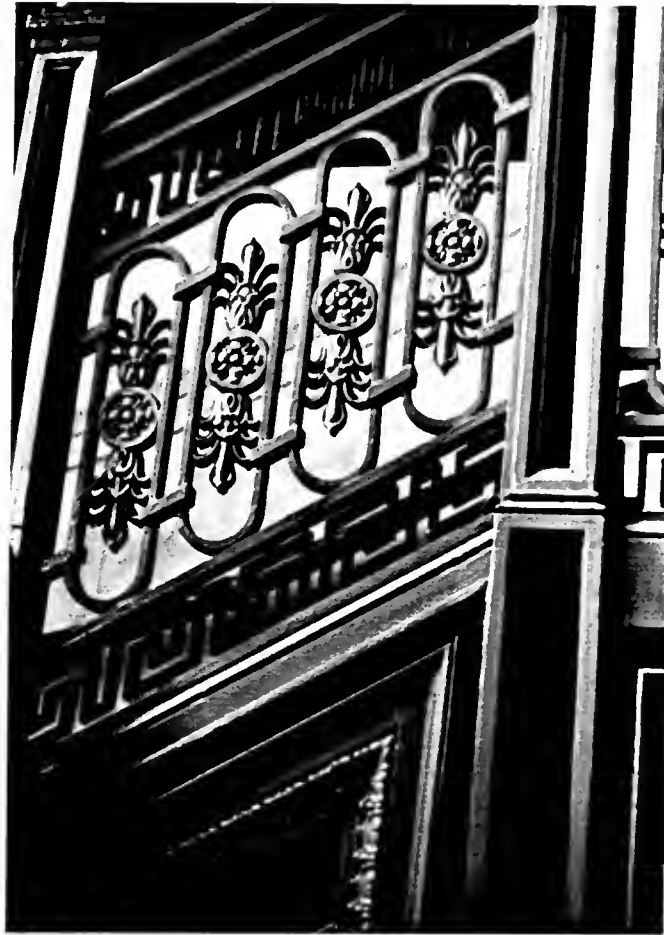
2-19; Balustrade, second floor stair.

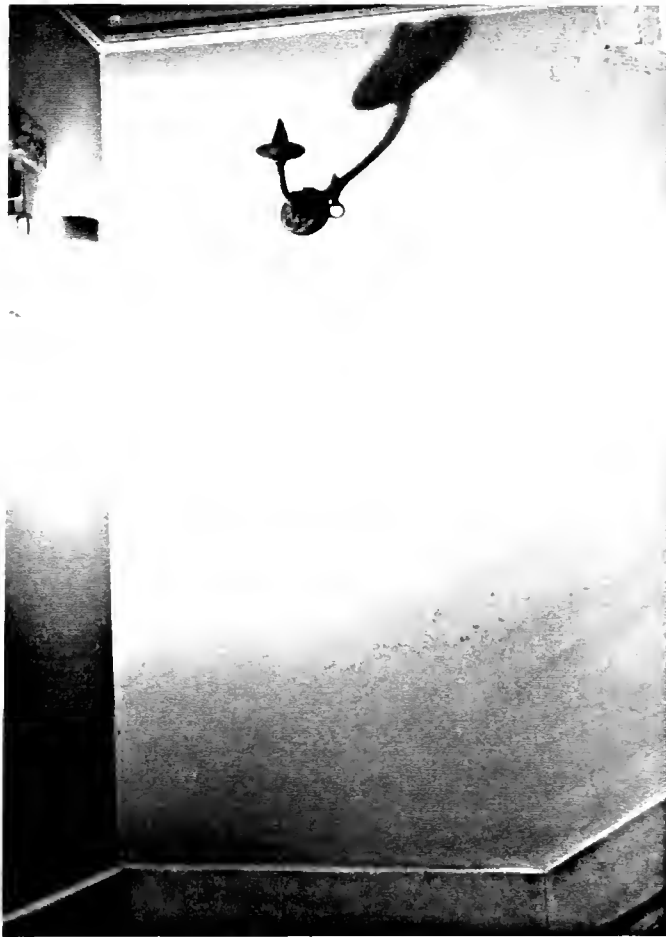
2-20; Original wall sconce, stairwell in SW corner, 3rd floor

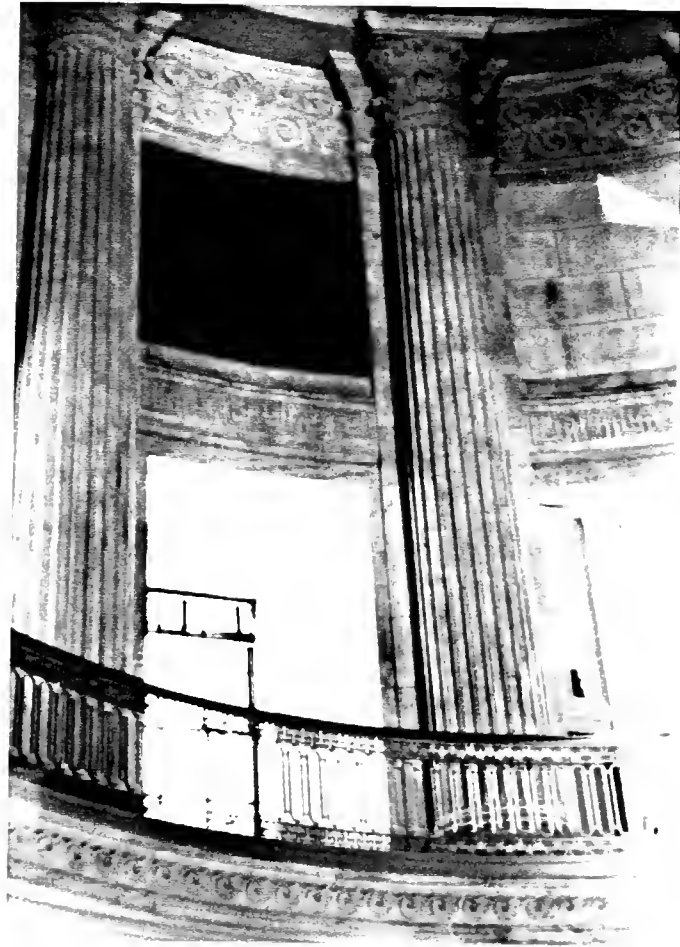
32 - View of Peabody and Stearns rotunda, showing painted bronze gallery rail and uneven tones of marble surfaces.

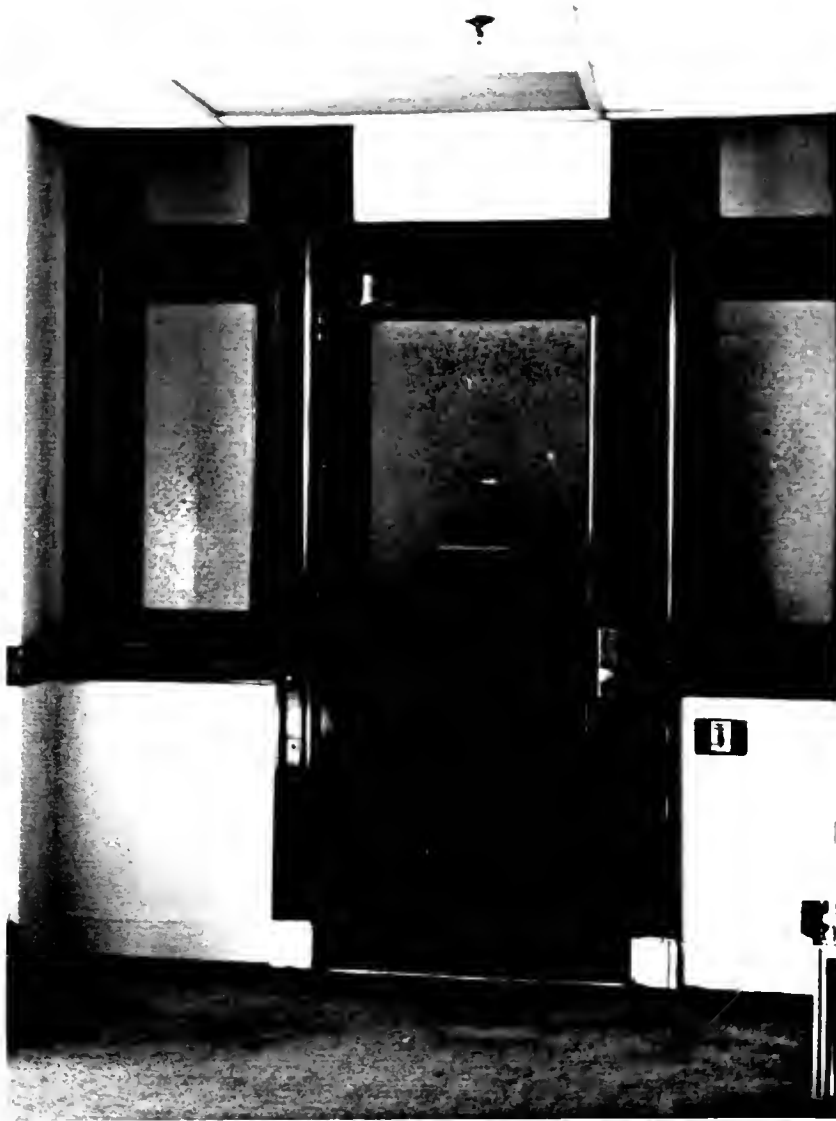
Figure 35

Element	Material/Description	Condition	Photo#
Floor	concrete	covered	
Base-board	painted orange terra cotta	chipped - 10%-20%	35
Walls	plaster, painted metal chair rail	good	
Cornice	none		
Ceiling	plaster above dropped acoustical	fair	
Windows	wood, Kalamine marble sills	(remove air conditioners) fair to good - needed paint & cleaning	34
Window Frames	grained (painted) metal	some chips	
Doors	painted grained metal frosted & clear glass	good, some chipped	35
Door Frames	(cf. above)	good	35
Hardware	modern brass-plated	good	35
Elect. Fixt.	egg-crate	good	36
Special Features			
Remarks:

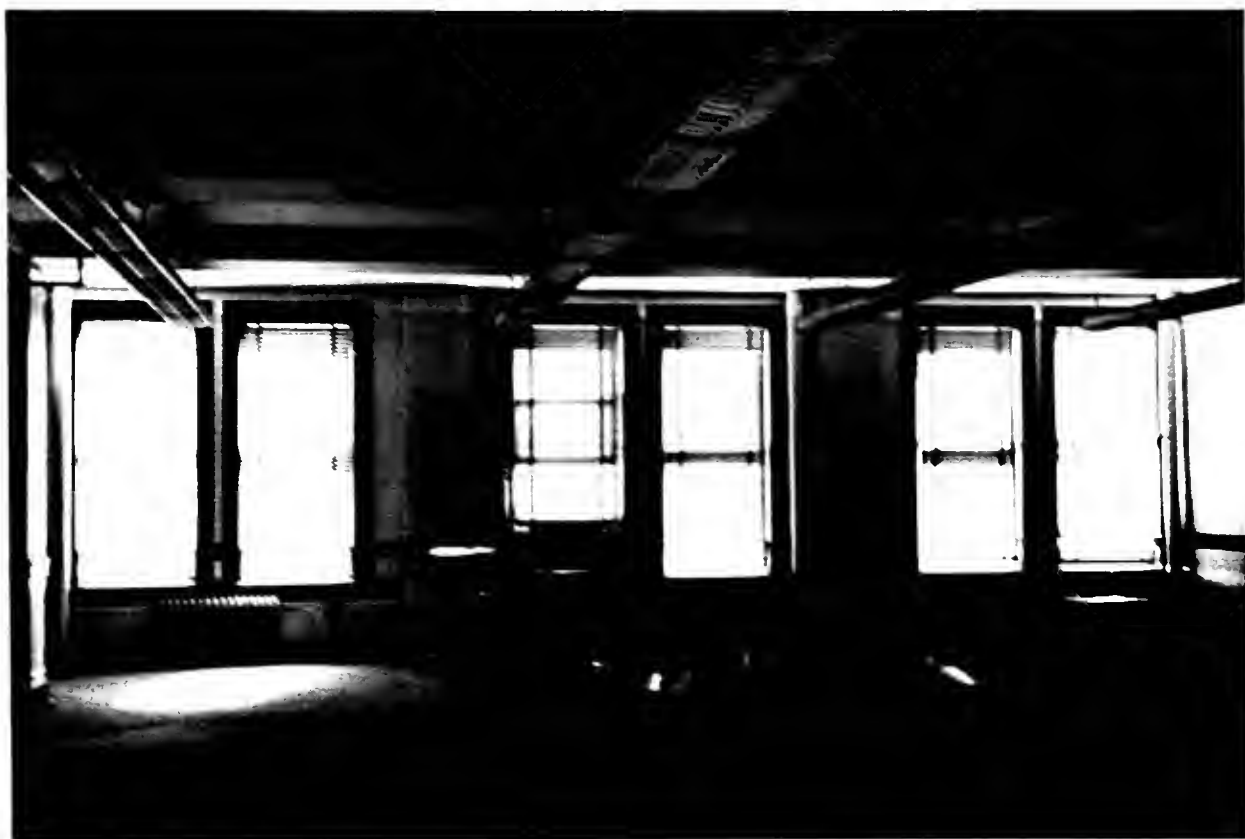
Figure 37

Element	Material/Description	Condition	Photo#
Floor	linoleum	worn, dirty	
Base-board	painted terra cotta	chipped	
Walls	plaster	fair to good - 20% peeling paint	
Cornice	none - some picture rail	fair	
Ceiling	dropped acoustical tile	fair	
Windows	same	corroded and dirty, chipped marble	37
Window Frames	same	blistered paint	37
Doors	same	(same as above)	37
Door Frames	same	(same as above)	
Hardware	same		
Elect. Fixt.	same		
Special Features			
Remarks:

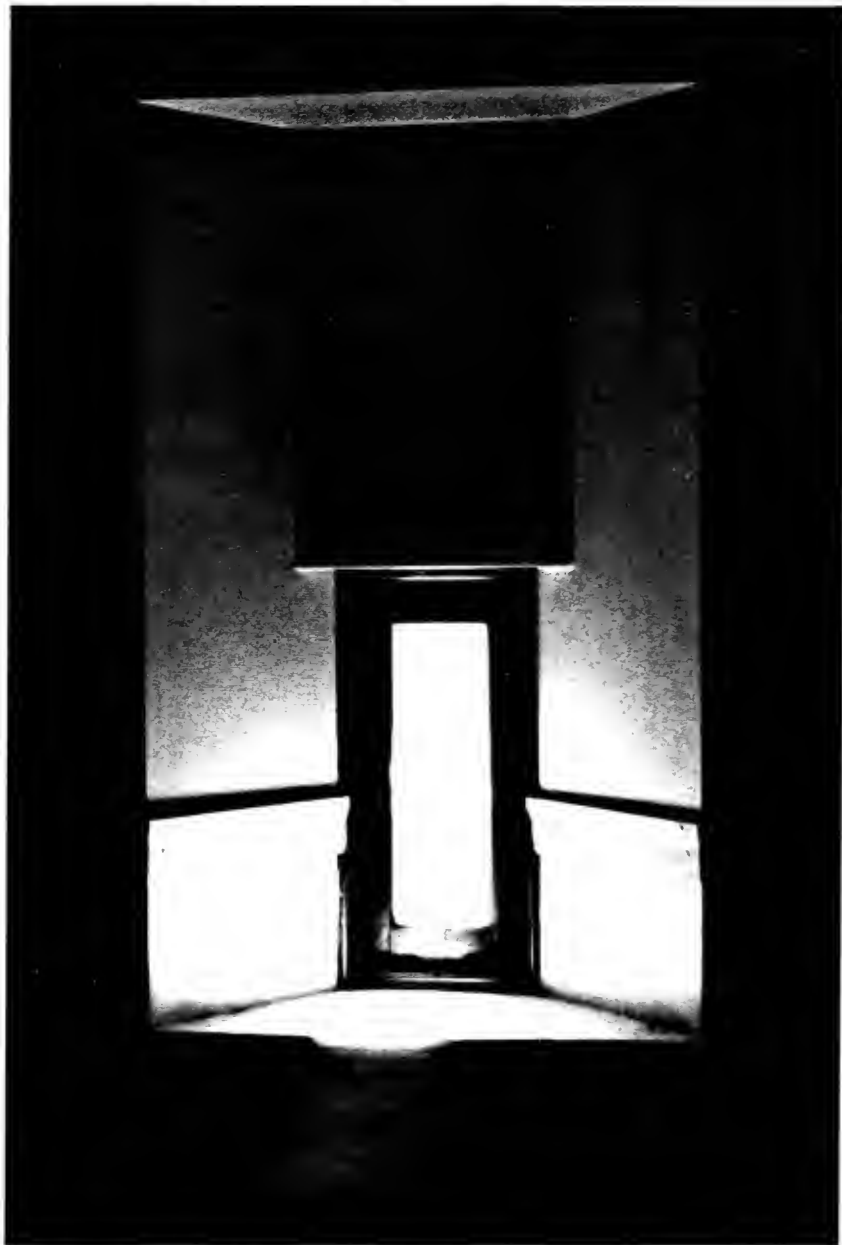
Figure 40

Element	Material/Description	Condition	Photo#
Floor			
Base-board			
Walls		25% peeling paint	
Cornice			
Ceiling			
Windows			40
Window Frames			
Doors			
Door Frames			
Hardware			
Elect. Fxt.			
Special Features			
Remarks: Typical of floors 6-18 but less fancy than the ninth floor.

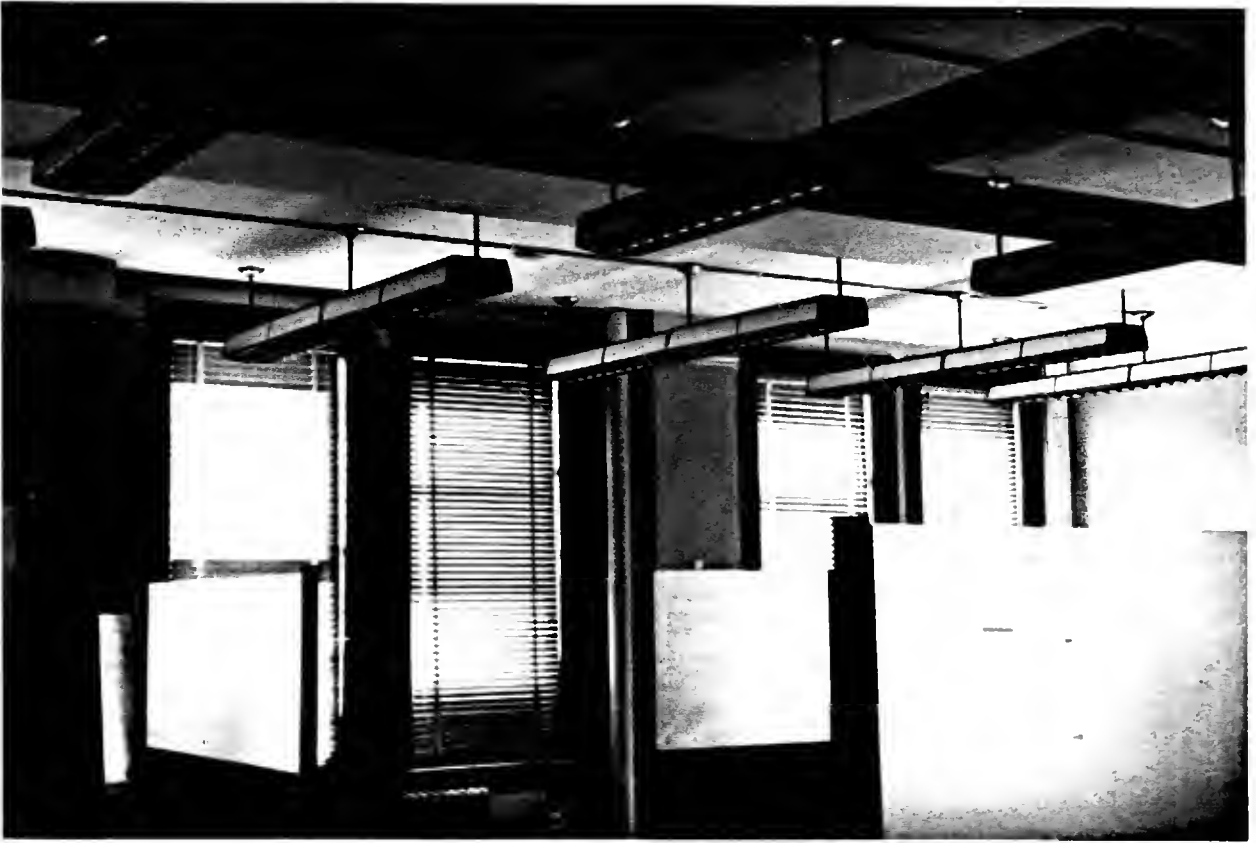
Figure 42

Element	Material/Description	Condition	Photo#
Floor	carpet		
Base-board			
Walls			42
Cornice			
Ceiling			
Windows			
Window Frames			
Doors			
Door Frames			
Hardware			
Elect. Fixt.			
Special Features			
Remarks:	Open now. All typical--lots of plaster and water damage on East.

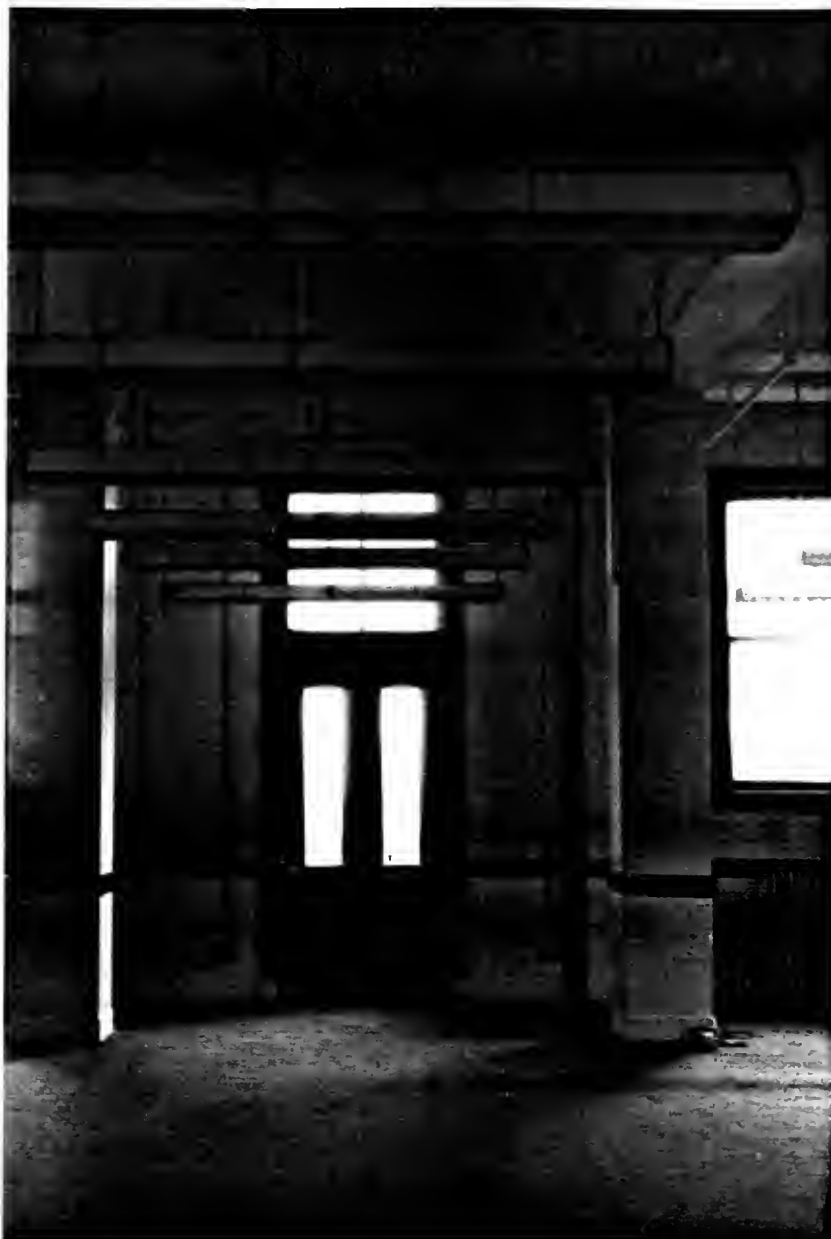
Figure 47

Element	Material/Description	Condition	Photo#
Floor	carpeted over granolithic	carpet good	47
Base-board	terra cotta, painted	some chips and nicks	
Walls	plaster, painted	water damage along east wall	48, 49, 50
Cornice	no - picture rail	good	
Ceiling	plaster, painted	signs of water damage North and East 10-15%	51
Windows	Kalamine	typical corrosion, but good	
Window Frames	painted graining on metal	good, sills are marble and soiled	52
Doors	painted metal and glass	fair	
Door Frames	painted metal	fair	
Hardware	brass plated	fair to poor	
Elect. Fixt.	egg crate	poor	
Special Features

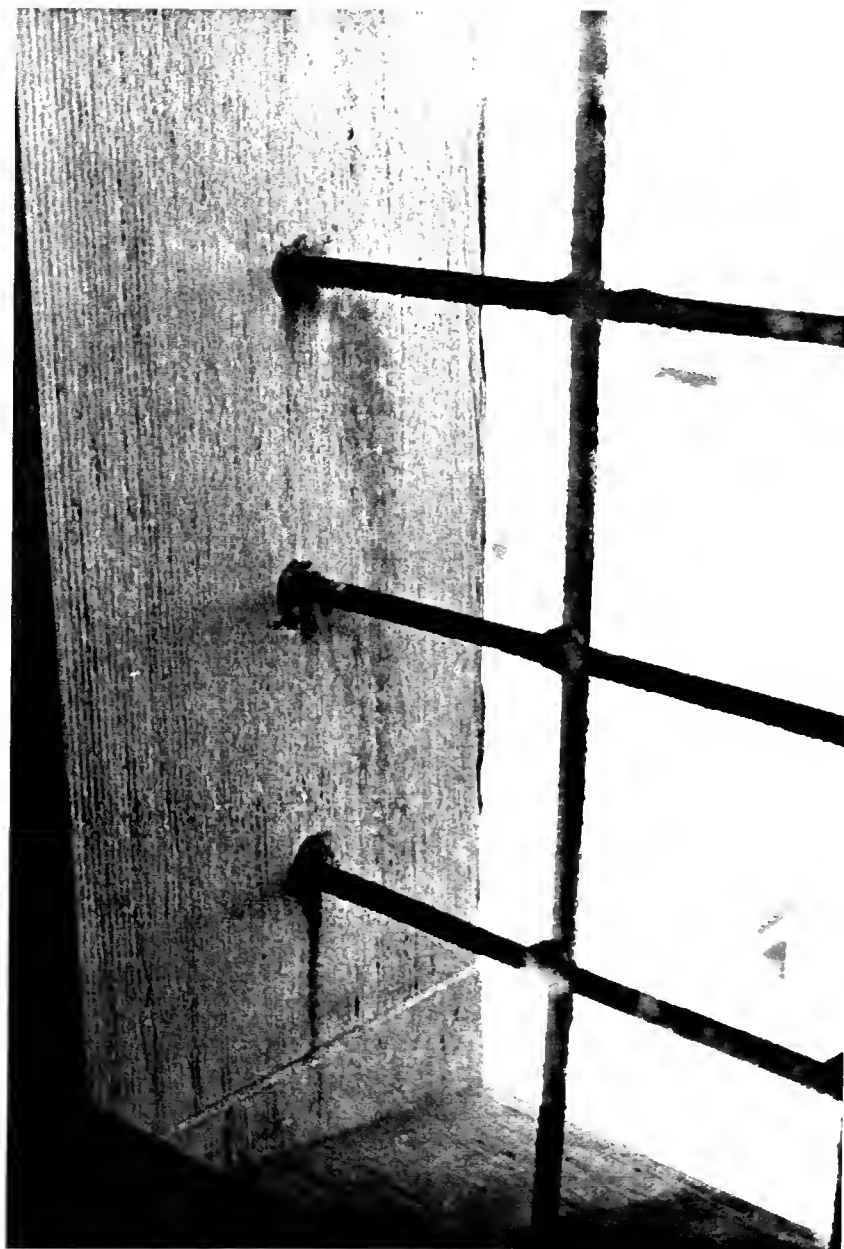
Figure 54

Element	Material/Description	Condition	Photo#
Floor	carpet or linoleum over ?	poor	
Base-board	painted terra cotta	fair	
Walls	plaster and wall board	fair to poor	
Cornice	(picture rail exists)		
Ceiling	dropped acoustical tile	poor - broken	
Windows	small, simpler, very typical	fair to good	53, 54
Window Frames	small, simpler, very typical	fair to good	
Doors	small, simpler, very typical	fair to good	
Door Frames	small, simpler, very typical	fair to good	
Hardware	small, simpler, very typical	fair to good	
Elect. Fixt.	removed		
Special Features

Remarks: East wall not peeling here; iron grilles over east sash set into exterior marble and badly rusted. Small corner windows at floor level add much light.

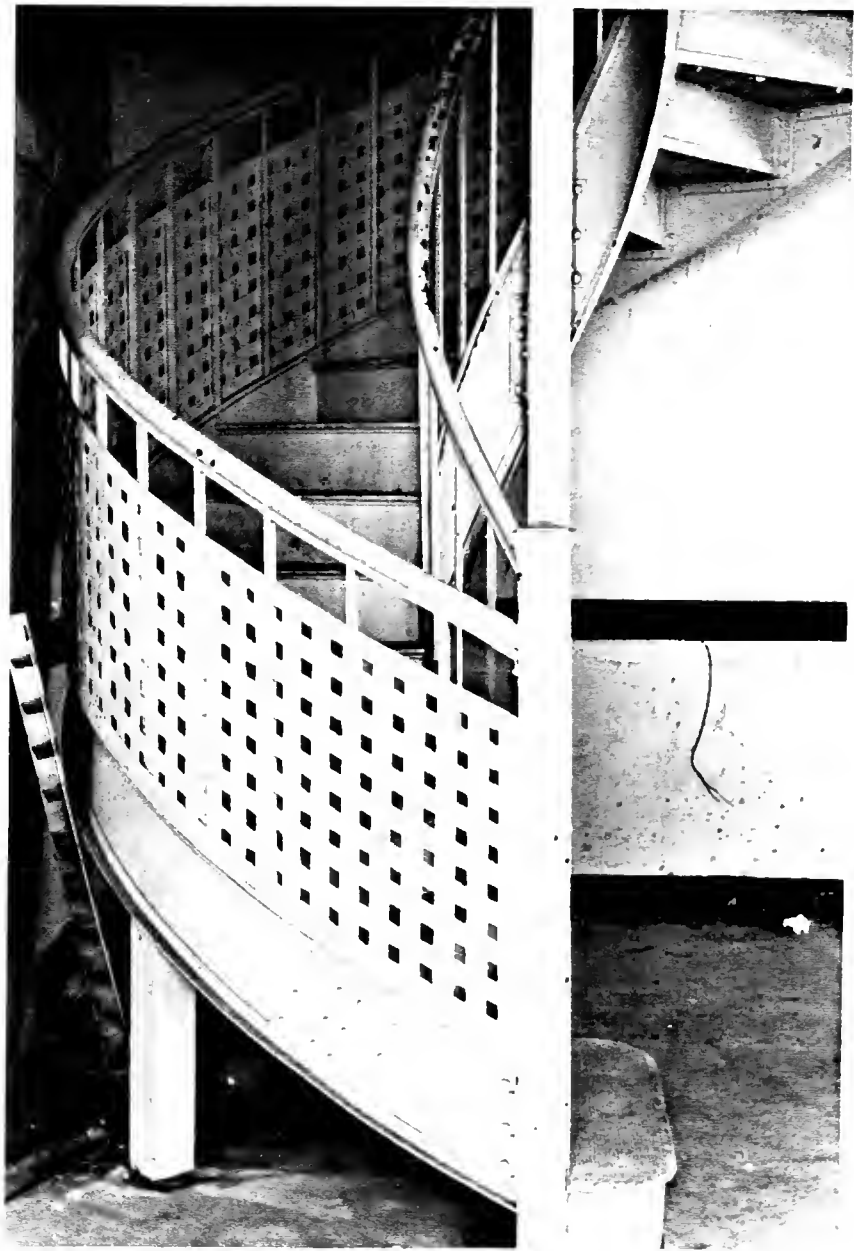
Figure 58

Remarks: In Southwest stair - much damage to plaster walls and ceiling - new? Iron spiral stair original - keep. Leaks from above on all exterior walls except South. 58, 59, 60

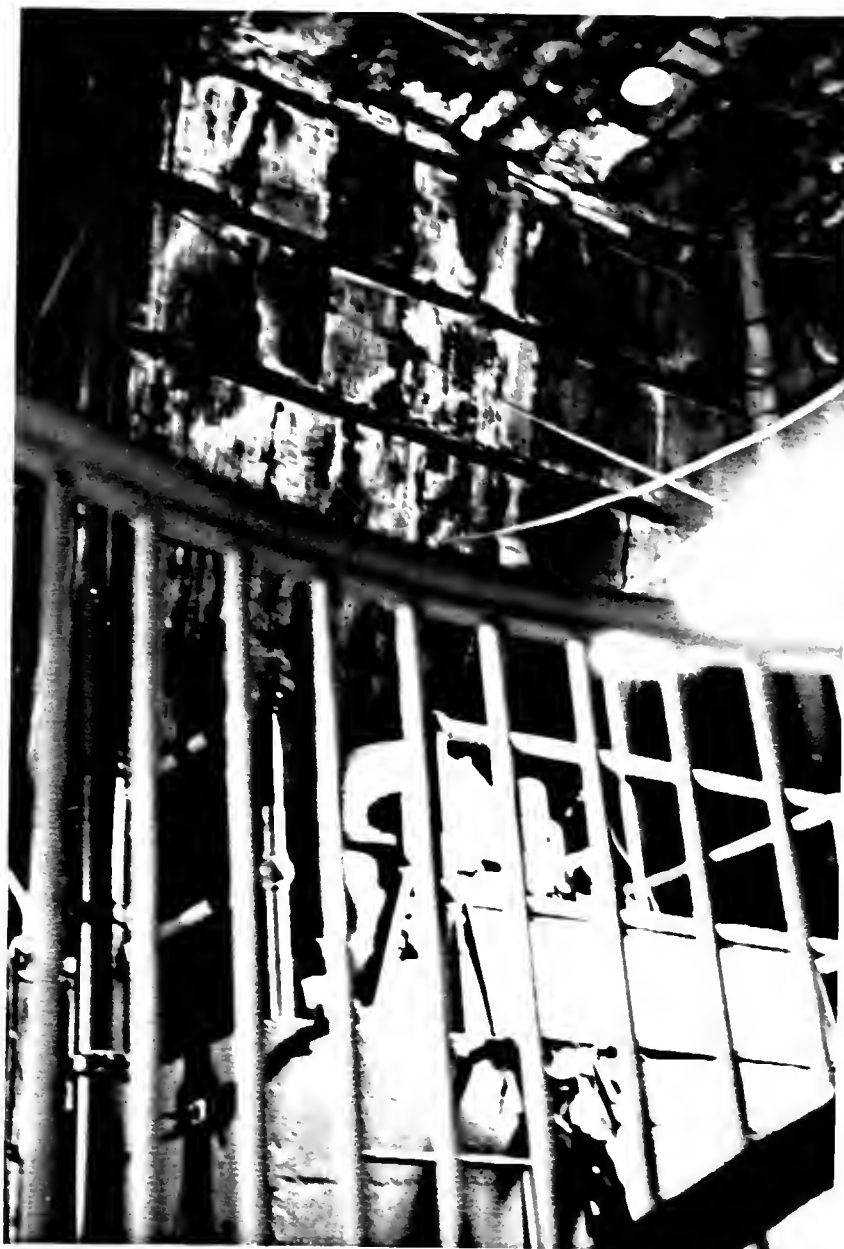
Figure 61

Element	Material/Description	Condition	Photo#
Floor	scored concrete	painted and inpainted	
Base-board	none		
Walls	exposed grooved terra cotta block	all effloresced, plaster remnants	61
Cornice	none		
Ceiling	exposed grooved terra cotta block		
Windows	none		
Window Frames	none		
Doors	none		
Door Frames	none		
Hardware	none		
Elect. Fixt.	fluorescent bars		
Special Features			
Remarks: No windows. Balustrade is basket weave ironwork. Plaster parging all gone.

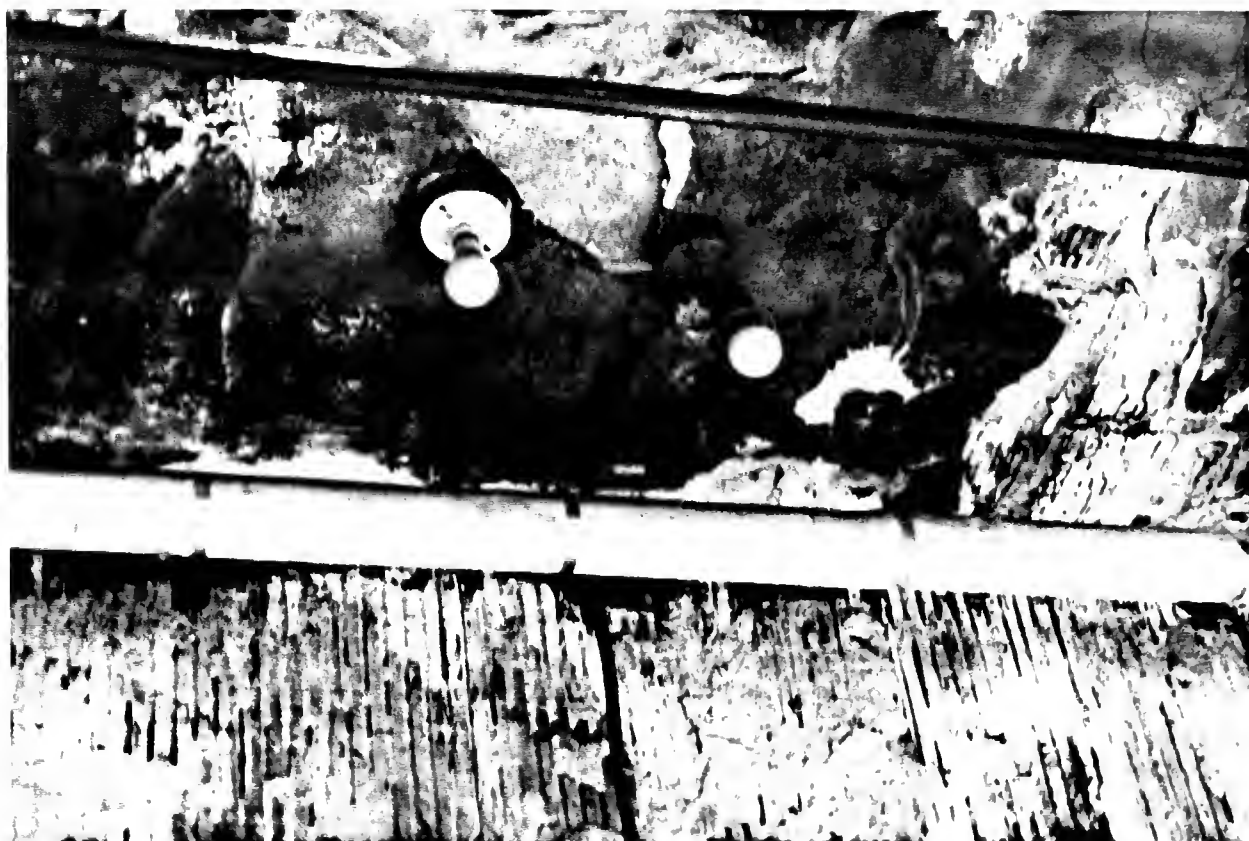
Figure 62

Element	Material/Description	Condition	Photo#
Floor	smooth but textured concrete	poor	
Base-board	flat red terra cotta	poor to fair	
Walls	grooved terra cotta block	poor - all effloresced, minor plaster remains	
Cornice	none		
Ceiling	plastered, painted gray	all cracked and peeling	62
Windows	Kalamine	fair	63
Window Frames	Kalamine	fair	
Doors	none		
Door Frames	none		
Hardware	none		
Elect. Fixt.	none		
Special Features

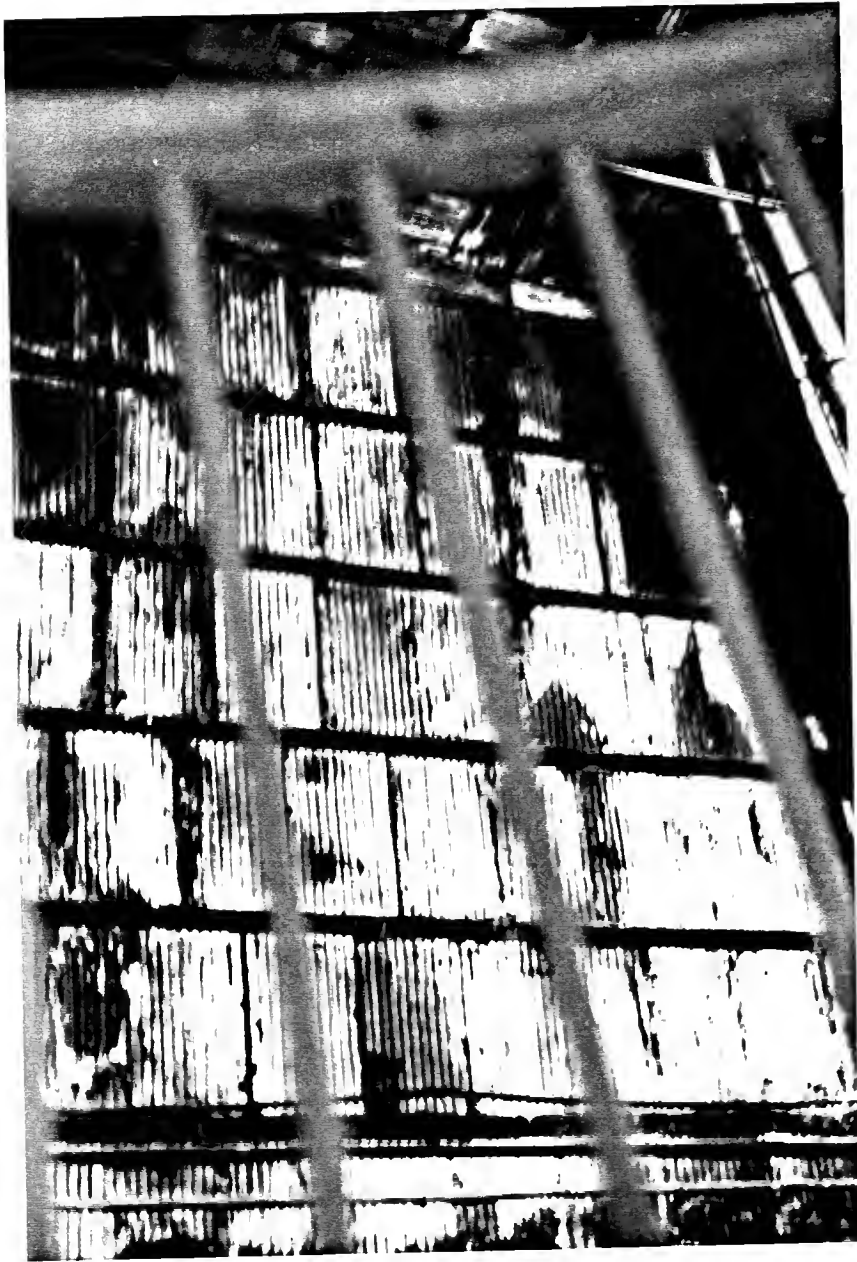
Figure 64

Element	Material/Description	Condition	Photo#
Floor	smooth but texture of concrete	poor to fair	
Base-board	red terra cotta	poor to fair	
Walls	grooved terra cotta block	formerly plastered on terra cotta - now bare and damp	64, 65, 66
Cornice	none		
Ceiling	grooved terra cotta block		
Windows	grooved terra cotta block (only 2/wall)		
Window Frames	grooved terra cotta block		
Doors	none		
Door Frames	none		
Hardware	none		
Elect. Fixt.	2 bare bulbs in ceramic sockets		
Special Features			
Remarks:	All is effloresced.

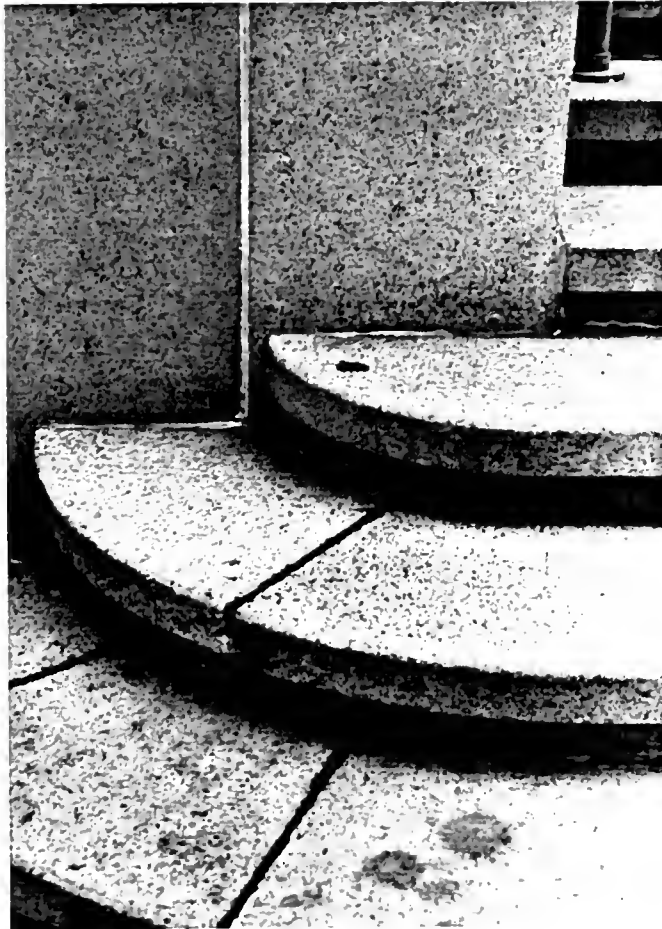
3 - Detail of stairs to west entry showing need for pointing and caulk.

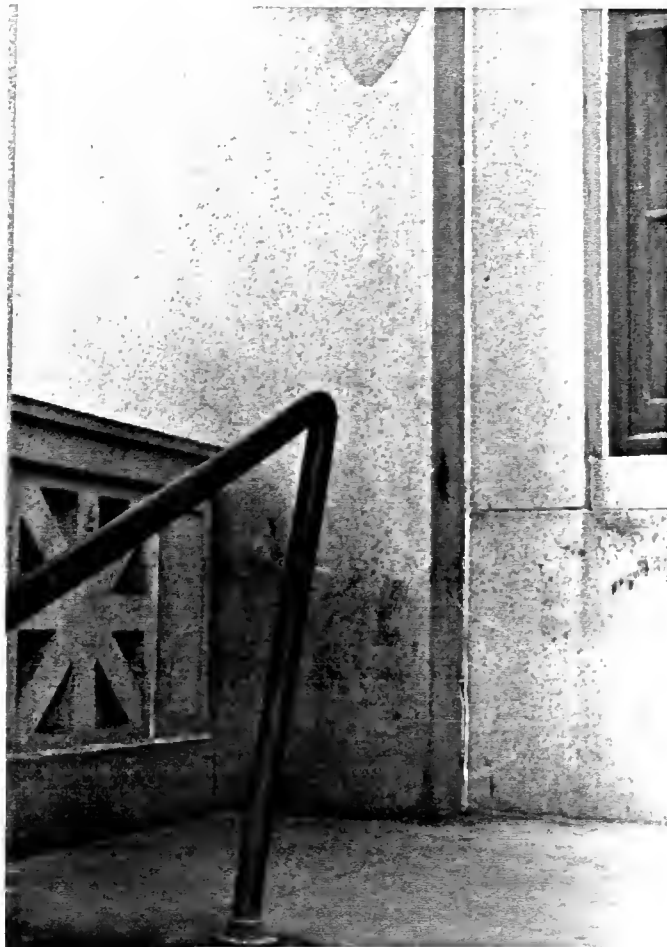
4 - Detail of bent handrail, north side of west entry.

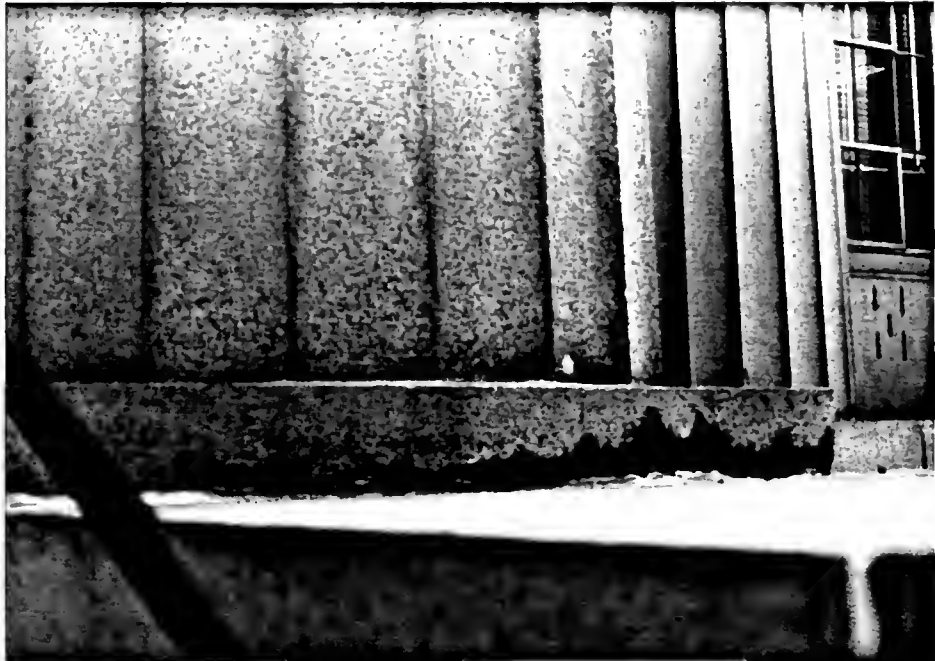
5 - Detail of chipped base of granite column of west facade.

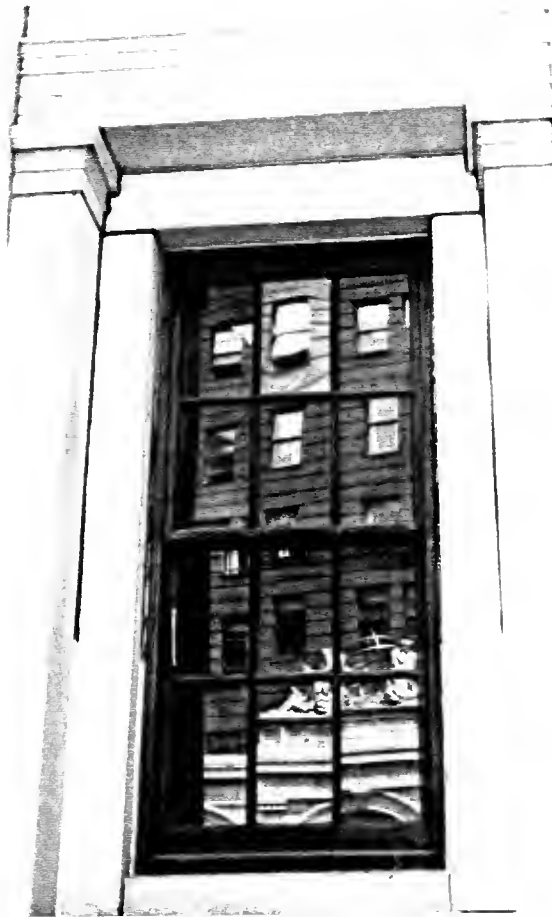
6 - Window over west entry doors, showing black caulk used poorly.

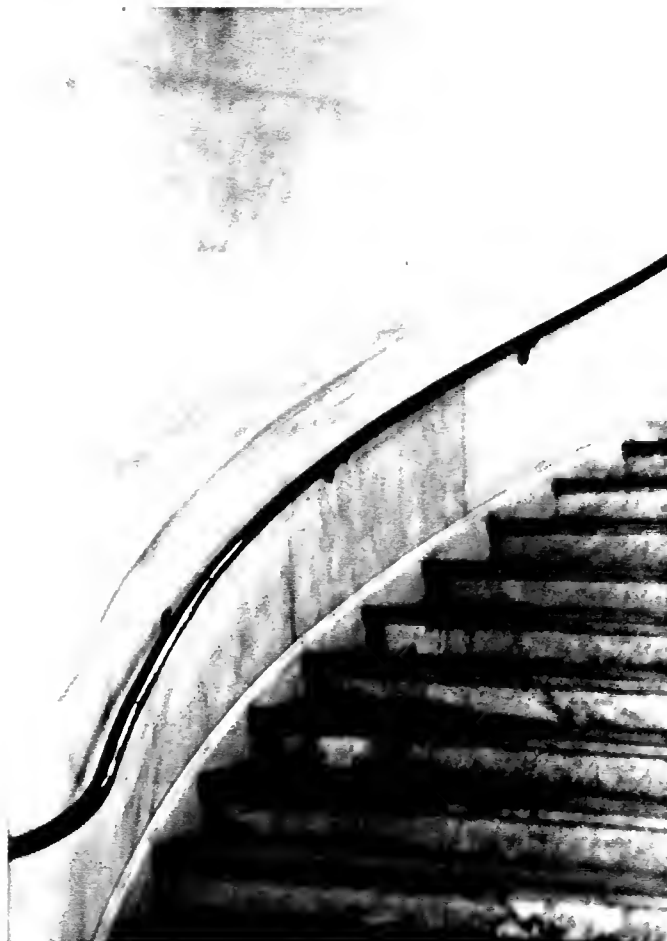
24 - View of the main stairs (Peabody and Stearns) to the second floor showing granolithic treads placed on top of marble, c. 1950, and general uneven appearance of marble.

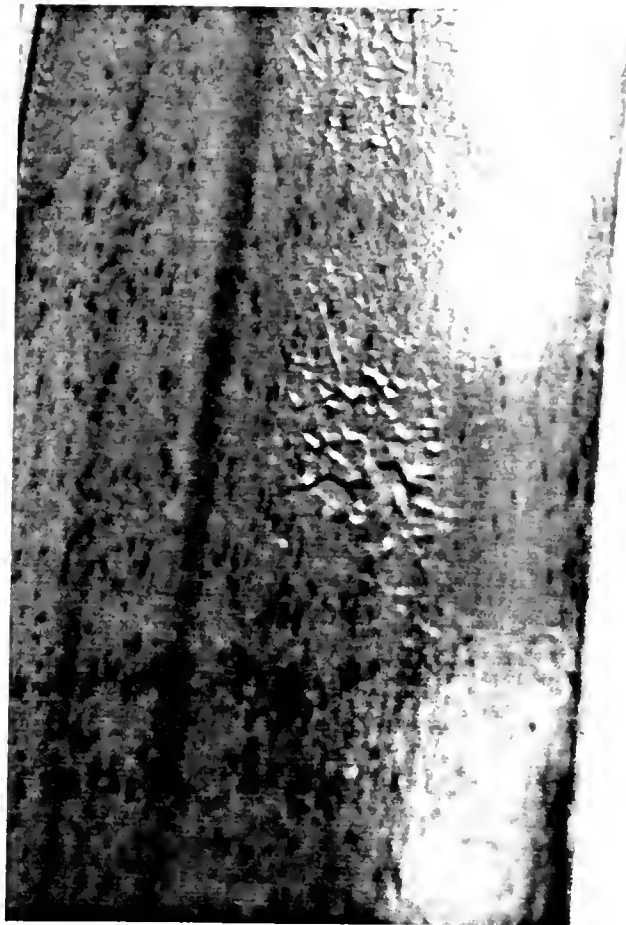
27 - Detail of painted graining on metal door outside Banking Room, showing a paint problem typical on about 2% of the surfaces.

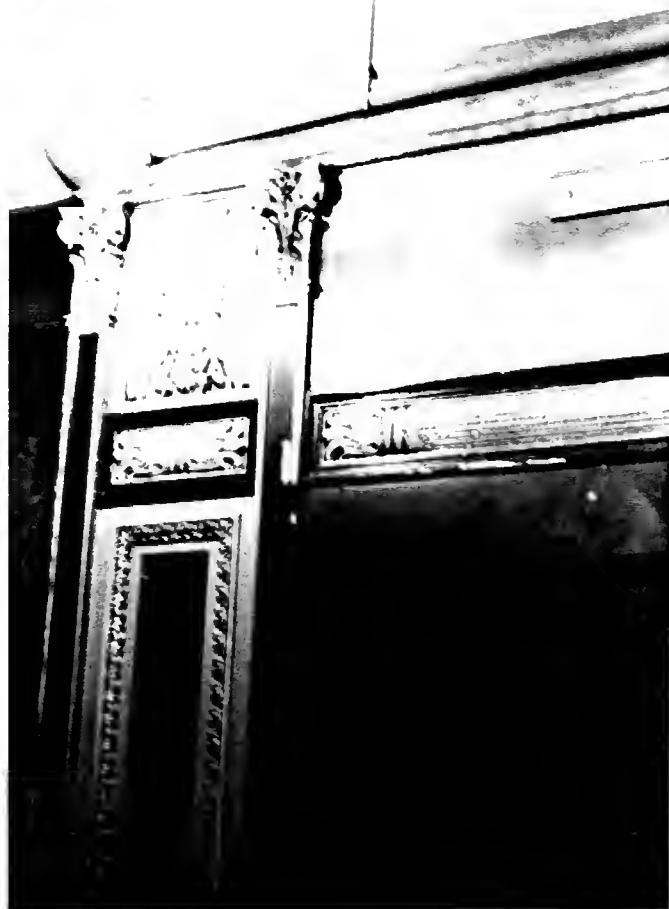
28 - View of elevator detail on second floor, showing trim which post-dates Peabody and Stearns, and was originally painted with a bronze gold paint when new.
